# Ten Year Report (2010 - 2019)

Will our love of glass cost us our birds?

# City Wildlife's *Lights Out DC*Bird/Glass Collision Monitoring Project Ten Year Report (2010 - 2019) October 8, 2020

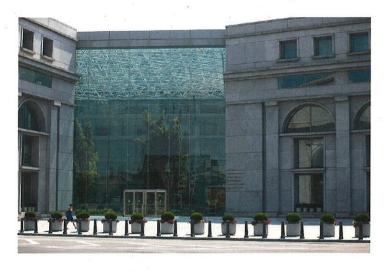
This building stood out as a problem from the beginning of monitoring by *Lights Out DC*. In 2010, more birds hit this building than any other, and the reason was clear: the tall glass wall at its entry gives full view of two large stands of live bamboo inside the atrium—and these trees were brightly lit all night. Adding to the problem, the building's exterior walls converge toward the atrium. A guard at the building said he could see birds flying across the circle toward the glass wall, heading for the trees and a certain collision. Soon afterward, City Wildlife contacted the Architect of the Capitol (AOC), which oversees this building, to discuss the issue. AOC personnel responded quickly by turning out all but the necessary safety lights in the atrium during migratory seasons, and by 2011, bird deaths at the building had decreased by two-thirds. However, large numbers of strikes have continued because the trees are still visible to the birds.

Thurgood Marshall Federal Judiciary Center (1 Columbus Circle, N.E.)

AOC continues to maintain its reduced lighting levels and is testing other solutions to prevent these strikes.

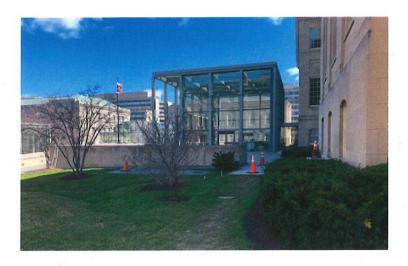
D.C. Courts 430 E Street, N.W.

This building is particularly deadly because it is entirely transparent. Birds simply do not see the glass and attempt to fly to the trees on either side of the pavilion, colliding with the glass at full speed. An unusually high number of woodcocks and hummingbirds have hit this building. When notified of the problem, the Court's building managers readily agreed to dim the pavilion lights during migratory seasons, but the strikes and high mortality rate have continued. The Courts are continuing to explore ways to reduce the number of bird strikes.

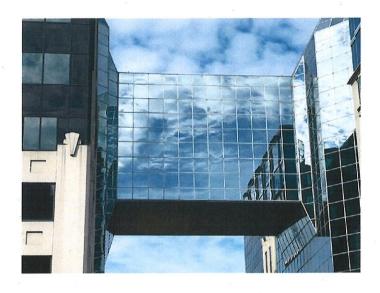
800 K Street, N.W. Mirrored glass overpass

This complex consists of two separate buildings connected by a mirrored glass overpass over what is technically Eighth Street but is now a pedestrian plaza. Until 2017, significant numbers of birds were hitting the overpass and falling directly below to the plaza. The building managers were notified of the problem in 2015, but they advised City Wildlife that the building was about to be remodeled. City Wildlife suggested that, as part of the job, film be installed on the overpass to cut down on its high reflectivity. Construction on the east building (700 K Street, N.W.) began in 2017 and is now complete, but the building was re-clad with even more glass and the overpass has remained unchanged. Recorded bird strikes were lower during construction but have now resumed not only at the overpass, but around the newly clad

building as well. Between 2010 and 2019, 185 strikes were recorded at this complex, leading to 159 deaths, for a mortality rate of 86 percent.

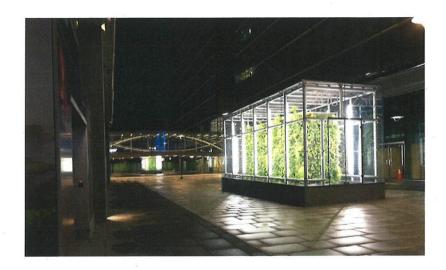
200-250 Massachusetts Avenue, N.W. (plaza)

Renderings show other features that are likely to create hazards for birds when adjacent to the building's reflective glass facades: abundant street trees, heavily landscaped rooftop terraces, and indoor plants. Birds already found at this site include two American Woodcocks, two Blackand-white Warblers, one Chimney Swift, two Ovenbirds, and one Yellow-billed Cuckoo, all Species of Greatest Conservation Need in the District. We encourage the developers of this project to incorporate bird-safe design features in the remaining buildings to be constructed before they too become hazards.

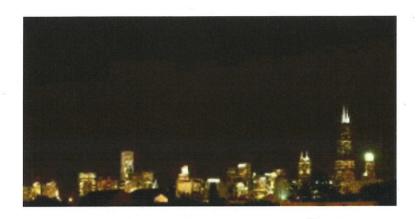
Chicago skyline before and after a voluntary Lights Out program took effect

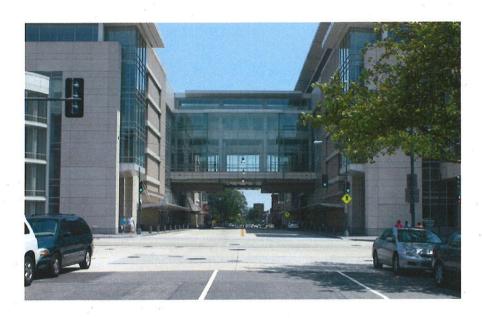
Walter E. Washington Convention Center
L Street overpass

In the early years of *Lights Out DC*, many birds were found at the base of the Convention Center's all-glass L Street overpass. By the fall of 2016, *Lights Out DC* volunteers had documented 135 bird strikes at the building, most at this overpass, even though the Convention Center had started dimming its overpass lights during migratory seasons.

2. The L Street overpass was the most hazardous part of the Convention Center prior to November, 2016, when Solyx Bird-Safety window film was installed on the overpass glass. The purpose of this spreadsheet is to determine the effectivness of the film in reducing bird strikes.

The second 3. Two calculations are used here to determine the total number of strikes at the overpass. These two calculations are necessary because prior to 2017, volunteers did not always identify where the bird was found at the Convention Center. However, volunteers generally specified the location only when the bird was found at a location other than the overpass, since that was where most birds were found. To be conservative, however, we have performed two calculations: the first calculation is conservative and assumes that only half the birds whose location was not identified were found at the overpass, which is more likely. Either way, the reduction from film is between 85% and 89%.
